Underground Storage Tanks

Underground Fuel Storage Tanks when left in place continue to prove themselves as major contaminant sources.

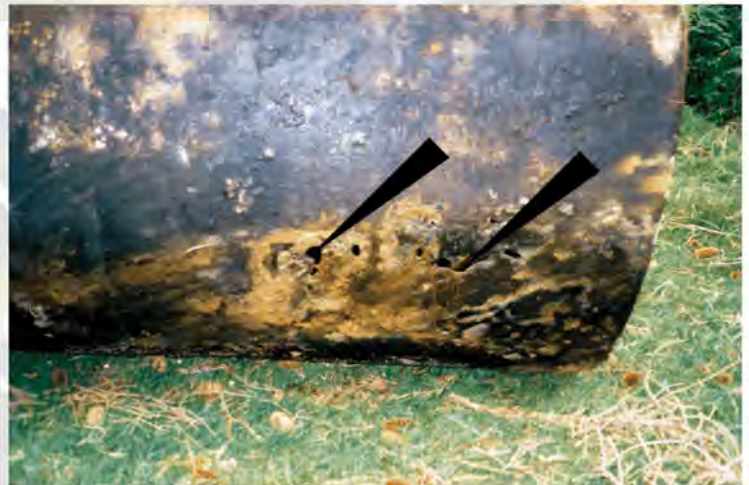
(Above) Example of a typical UST with large pin-hole perforations

Groundwater flow in the subsurface environment is the primary mechanism for which steel corrosion (cathodic loss) occurs. Corrosion of USTs usually starts with very small perforations in the metal which often results in tanks initially leaking quite slowly. Even if a tank has been pumped out and abandoned-in-place, there is still a thick layer of hydrocarbon sludge that remains along the bottom surface. Usually after a short period of time, the steel tank will start to fill up with groundwater. With continued metallic decay of the tank the concentrated sludge, mixed with groundwater starts to leak into the surrounding environment causing more and more subsurface contamination. Detection of a failed UST is normally after a considerable amount of fluid has been lost over many years.

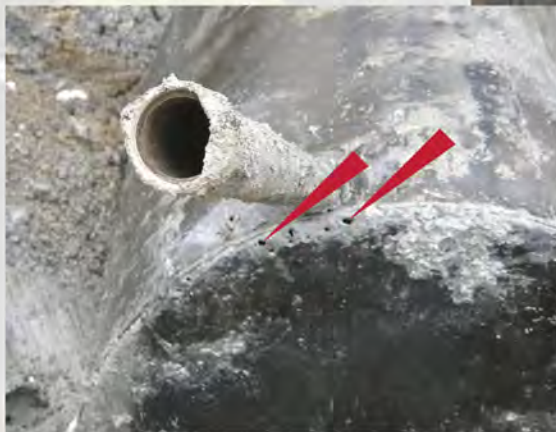
(Below) Another example of minute perforations
in the metal of USTs causing subsurface impacts.

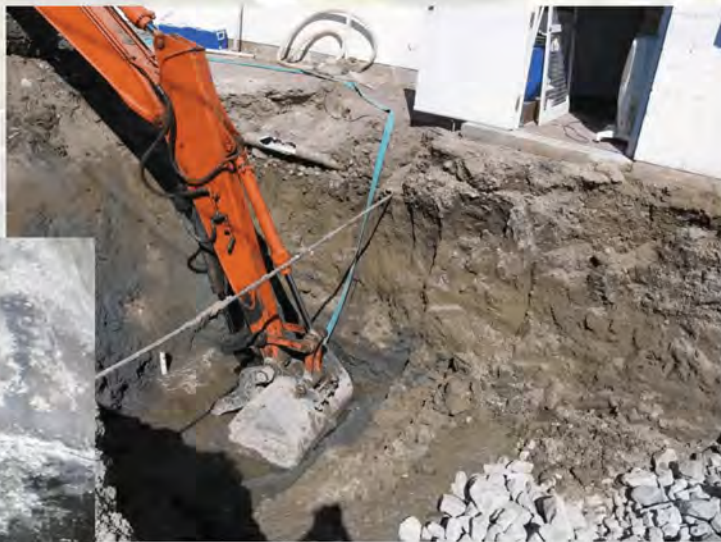
(Above) Costly excavation work
required under a building

Another common factor that we encounter is that when USTs are situated close to under permanent structures (buildings), fuel leaks can infiltrate the surrounding soils and migrate along drain tiles and/or under foundations. When this type of contaminant migration occurs, remediation can become incredibly costly due to either extensive excavation requirements undermining building stability, or *in situ* treatment (on-site) treatment techniques, which are usually quite a long-term project. Both forms of remediation can also seriously affect land titles and property values.
